Pinole Creek Demonstration Project Summary Report

April 30, 2013

Prepared for the City of Pinole
by Restoration Design Group
2616 8th Street, Suite B
Berkeley, CA 94710

Lower Pinole Creek Demonstration Project Risk and Uncertainty Analysis

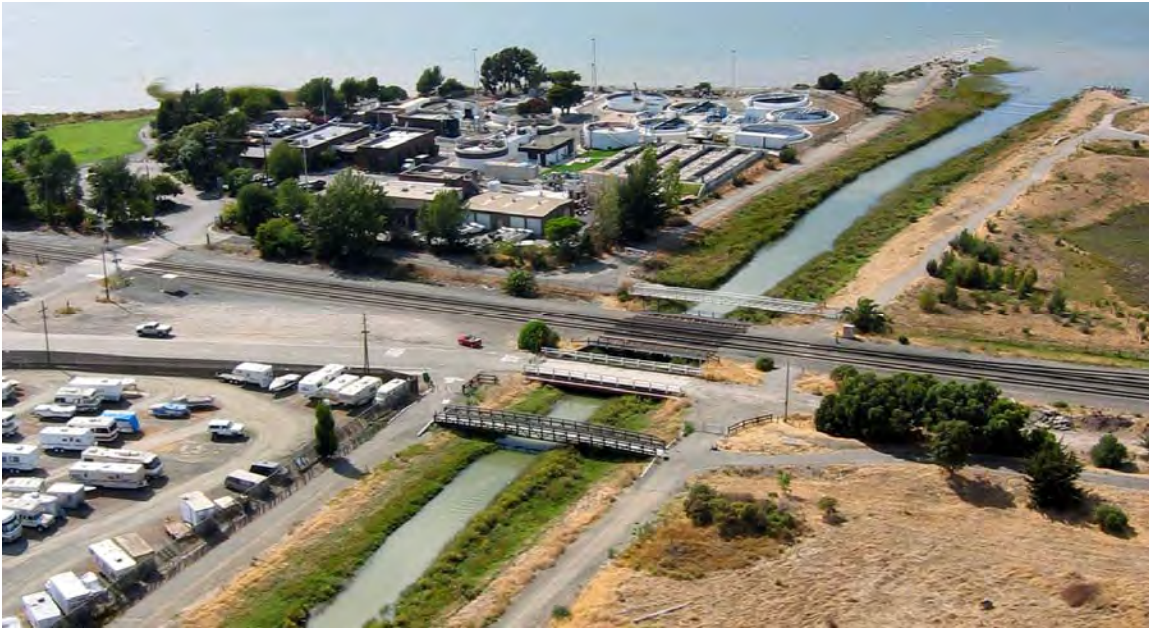
Photo 1. Kite aerial of the mouth of Pinole Creek pre-restoration

At the mouth of the creek are four bridges which (to varying degrees) constrict the channel and reduce flood conveyance. Furthest downstream is the Bayfront Bridge, a bike and pedestrian bridge that is part of the Bayfront Park Loop Trail. The bridge provides pedestrian access to Bayfront Marsh. The next upstream bridge is the Union Pacific Railroad (UPRR) Bridge. Immediately upstream of the UPRR Bridge is Railroad Avenue Bridge, a vehicular bridge. The Railroad Avenue Bridge has the greatest impact on flood conveyance. The fourth bridge is the Bay Trail Bridge that provides pedestrian and bike access across the creek for users of the Bay Trail. All four bridges are pictured in the photo above (Photo 1).

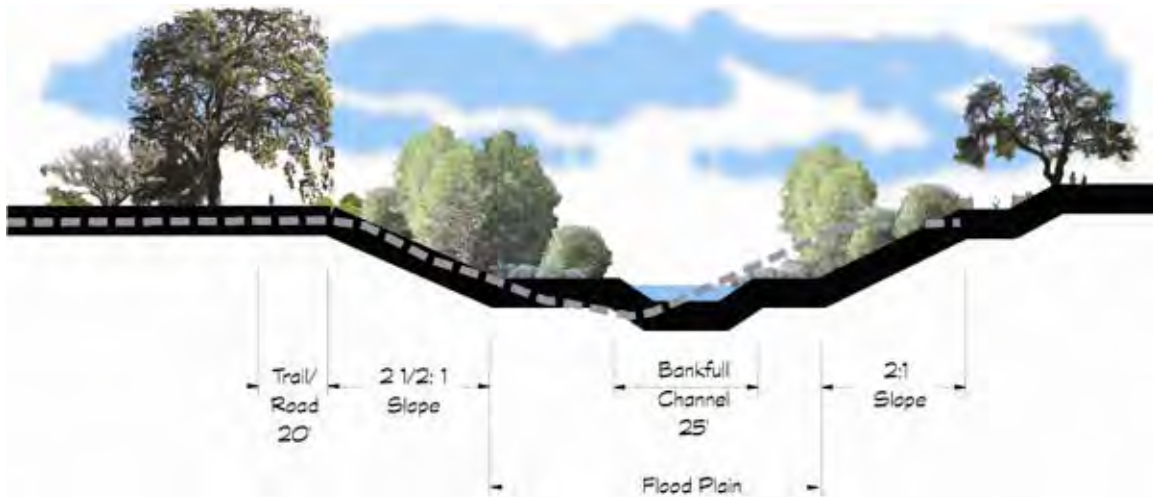
Fluvial Area Cross Section

Figure 3. Schematic diagram of Lower Pinole Creek Restoration Plan – fluvial area

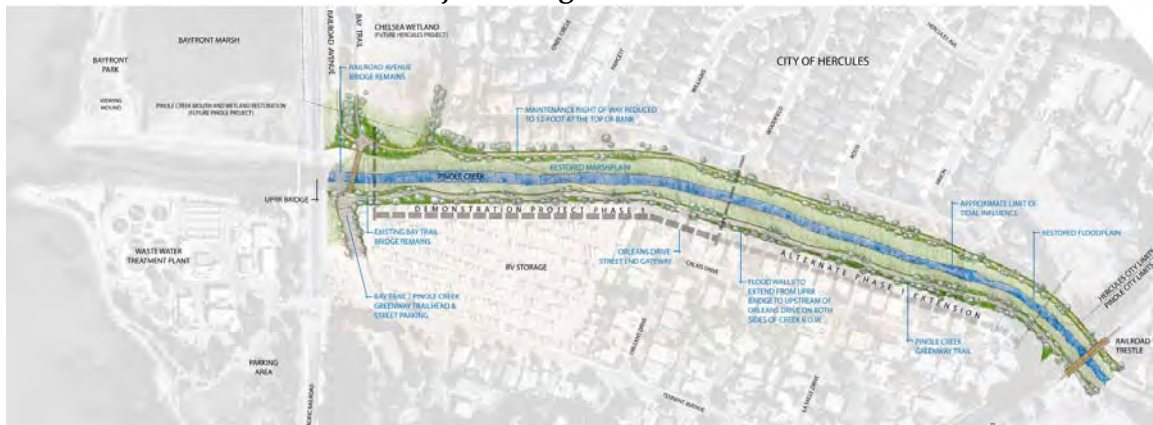
Figure 4. Schematic design of Pinole Creek Demonstration Project

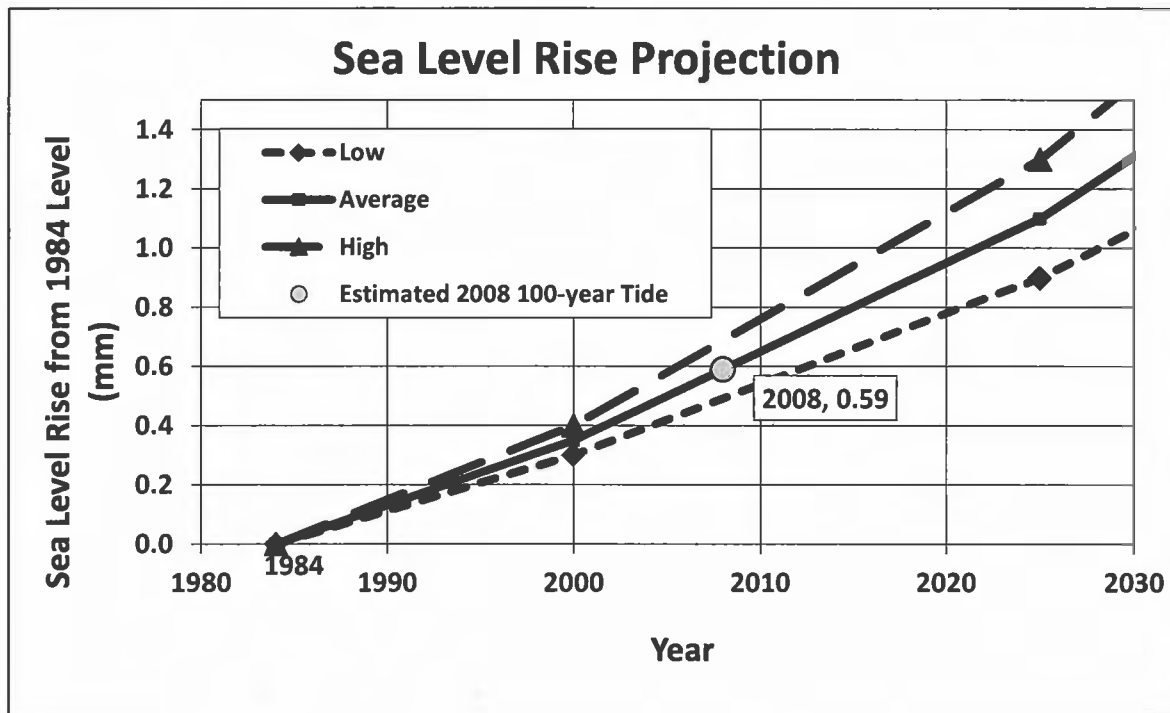
Figure 2 — Estimated Future Sea Level Rise based on table in Section 7 of the October 1984 "San Francisco Bay Tidal Stage vs. Frequency Study."

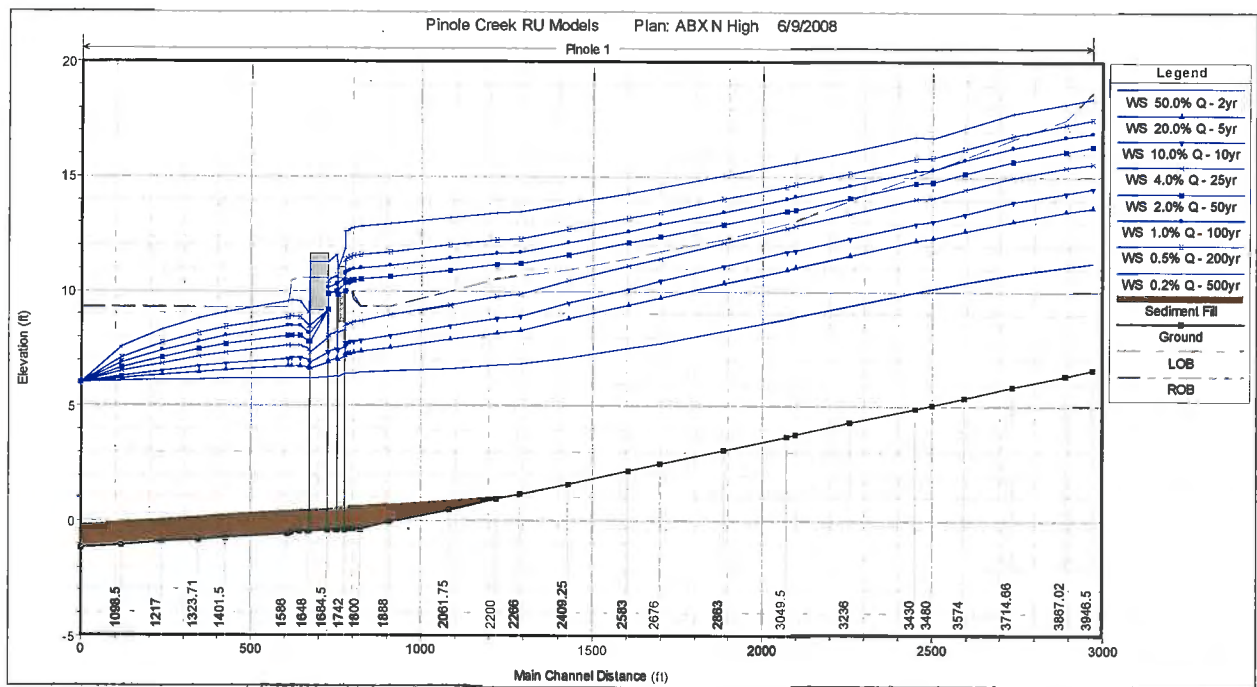
Figure 3 — HEC-RAS plot of the As-Built plan worst conditions profile showing the sedimentation assumptions.

Therefore, in the worst conditions geometry for the As-Built plan, we assumed one foot (1ft) of sediment on top of the As-Built channel bottom from the mouth up. We used the “Fixed Sediment Elevation” tool in HEC-RAS to fill the channel from the mouth upstream with one foot of sediment at the slope of the lower reach (0.001 ft/ft) and let that sediment intersect the channel after the grade break at station 18+00 where the slope changes to 0.00324 ft/ft upstream of station 22+00. **Figure 3** shows the depth and limits of this sediment accumulation as the shaded area in the lower part of the creek (left side of the profile).

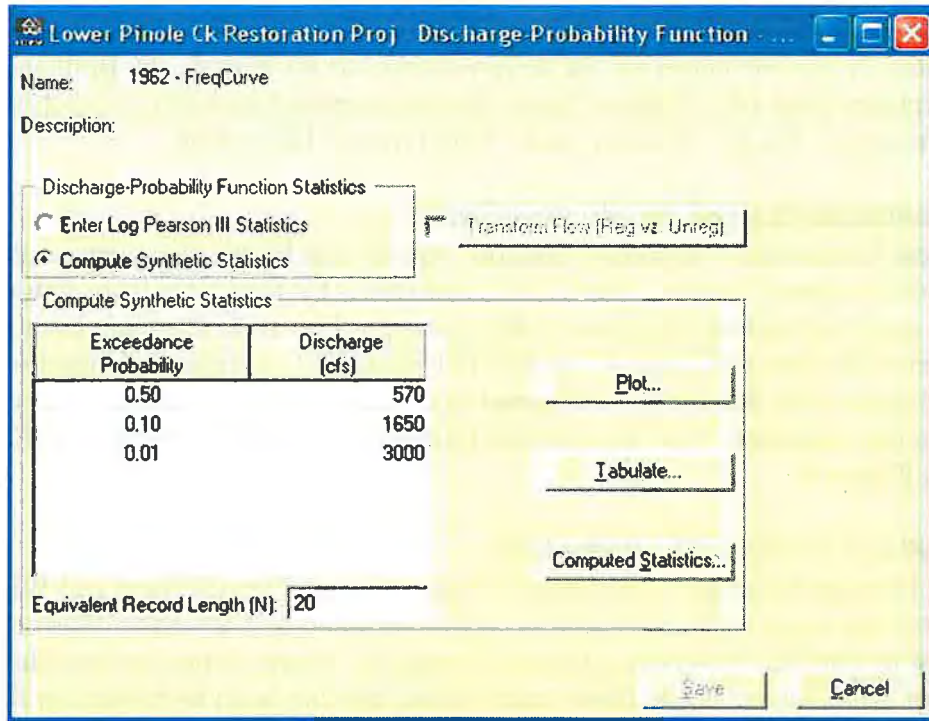
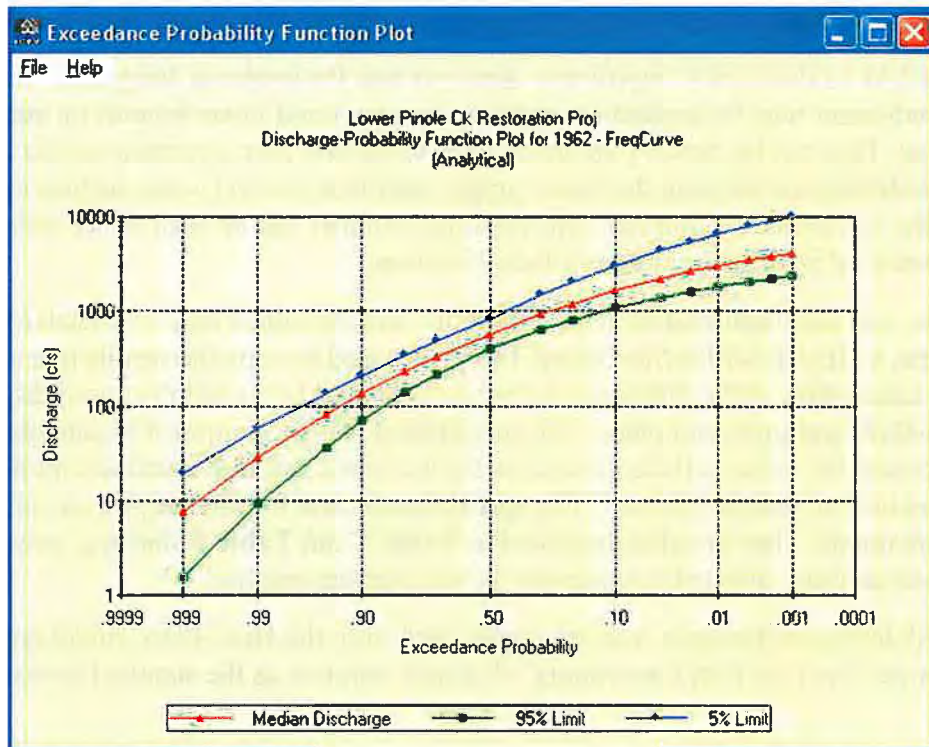
Figure 5 — Exceedance Probability Function with Uncertainty Input and Graph (screen shots from HEC-FDA).

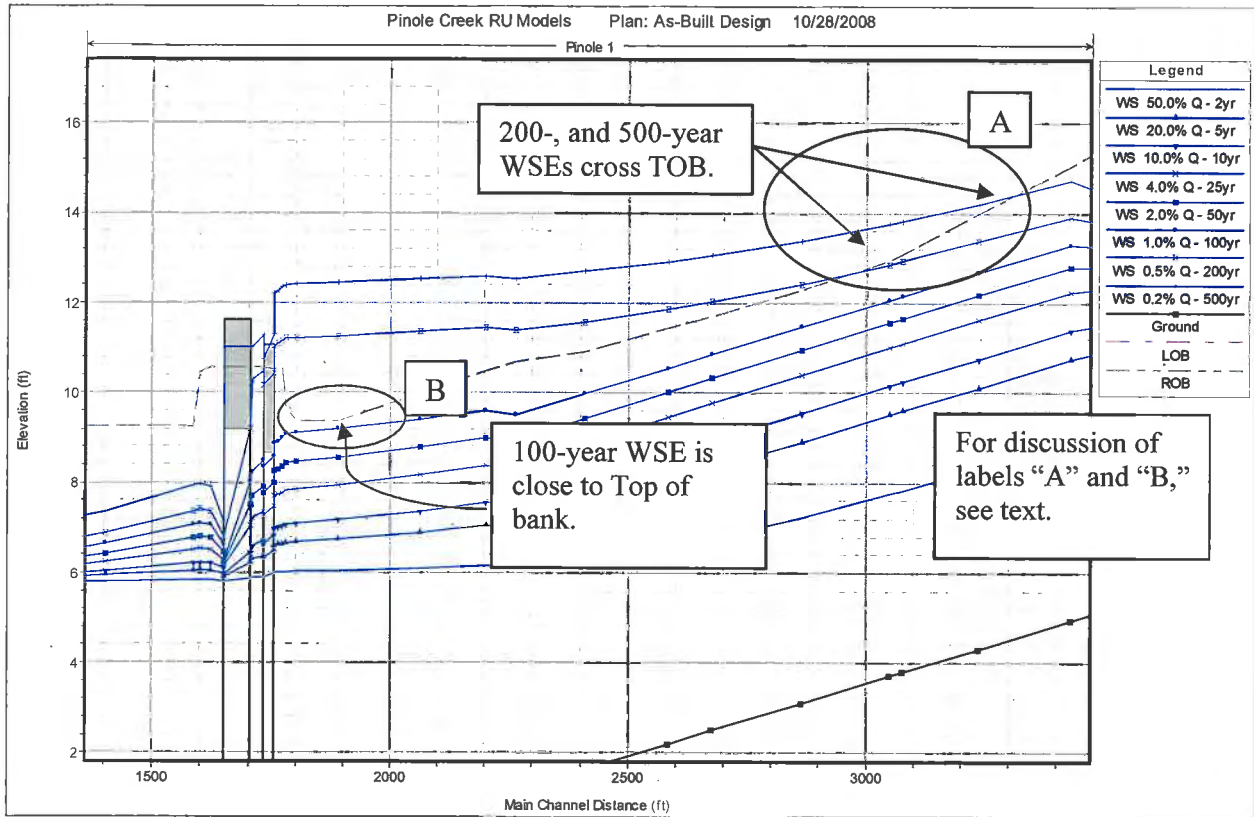
Figure 7 – HEC-RAS Profile of the As-Built Plan Design Conditions with Top of Bank Profile.

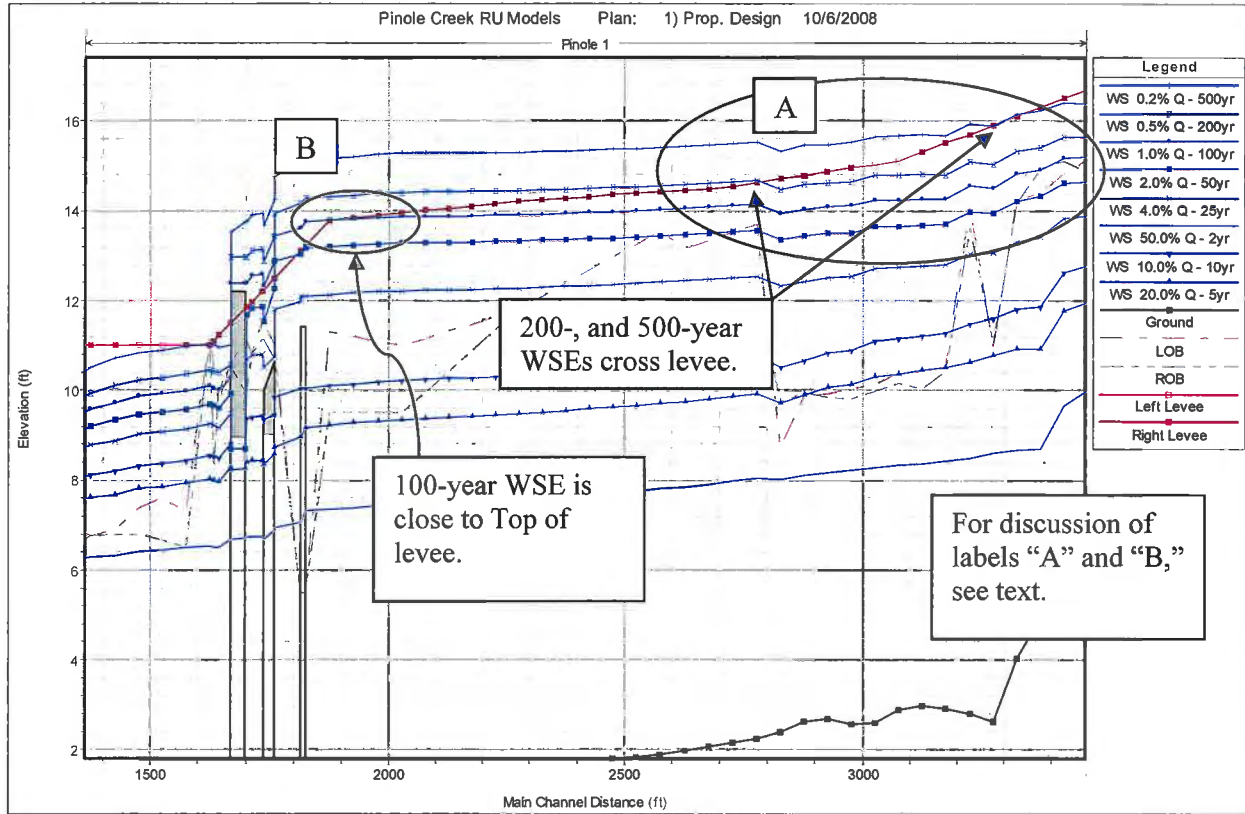
Figure 8 — HEC-RAS Profile of the Proposed Plan Design Conditions with Levees set at Recommended Height.

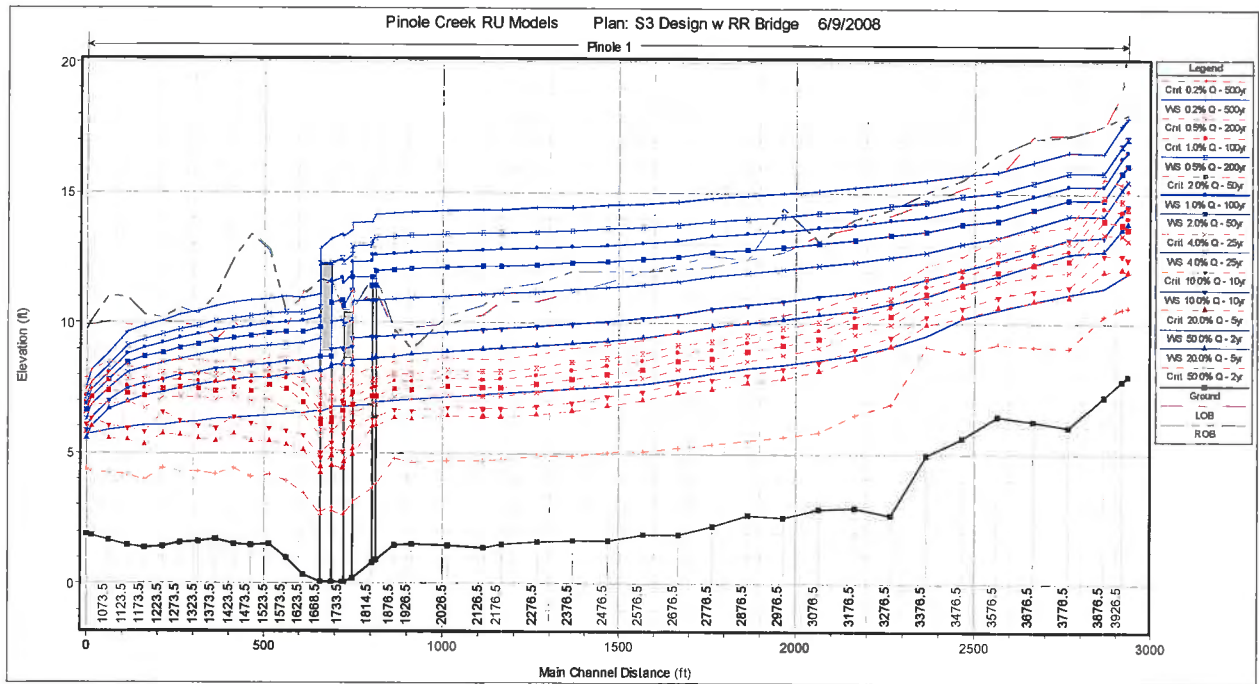
Figure 10 — HEC-RAS Profile of the Proposed Plan Design Conditions.

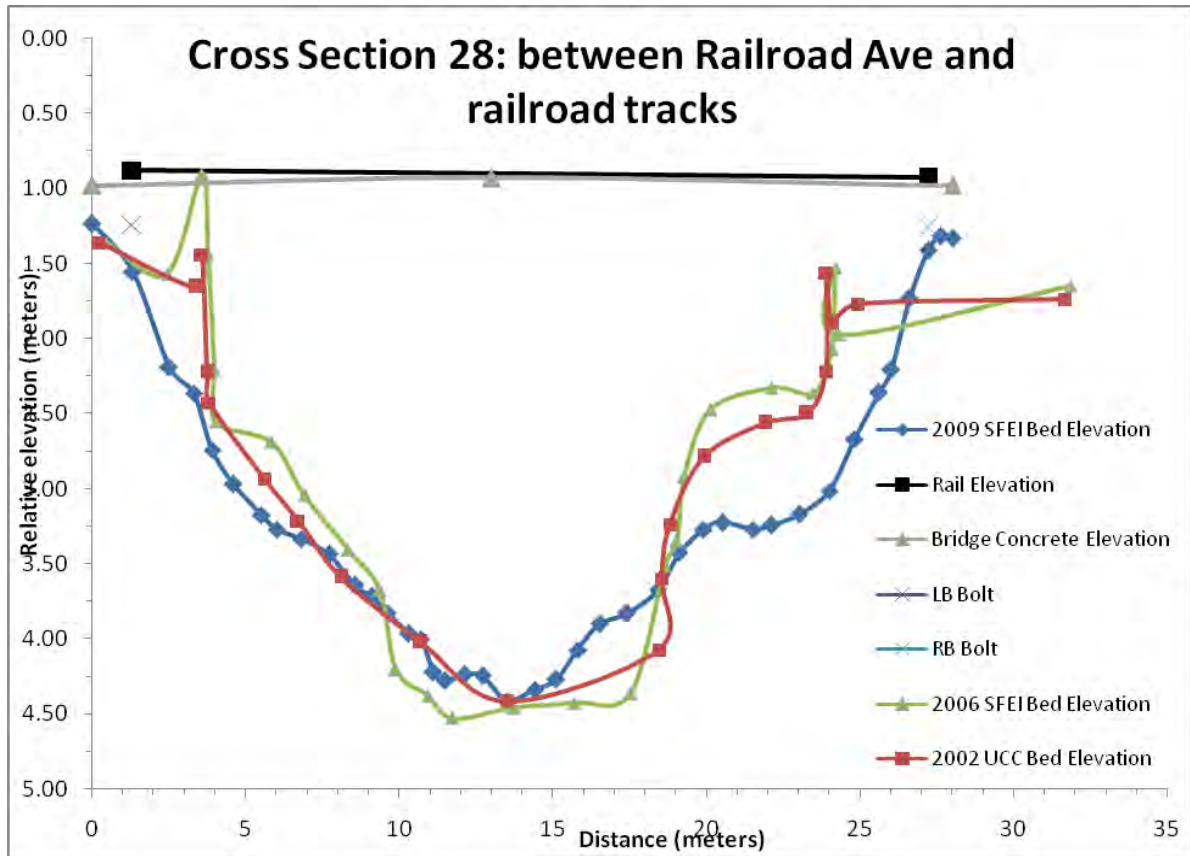
Figure 1a. Cross-section survey of Pinole Creek at the Railroad Bridge in August 2009.

Section 28 is located between Railroad Avenue and the railroad tracks, and is the furthest downstream of the three cross sections. In 2002 and 2006, the section was surveyed 1 m downstream of Railroad Avenue, however for this survey, we surveyed 1 m upstream of the railroad tracks (approximately 6 m downstream from the previous surveys). Drew Goetting of Restoration Design Group requested that this location be surveyed because it will capture the channel dimensions with the new (constructed in approximately 2008) railroad bridge, helping to better inform the designs for the Pinole Creek Demonstration Project. In 2009, this section illustrated the small benches that had formed in the tidal channel, dominated by *Spartina sp.* Although these sections cannot be directly compared, the general channel dimensions seem to be approximately the same. This section will be valuable for future comparison because it is tied into the railroad bridge elevation.

The channel has remained similar in its dimensions between 2009 and 2012, with only minor modifications in its shape; we observed slight sediment deposition on the right and left bank marsh plain surfaces, and minor widening of the main channel, but the channel bed has remained at the same elevation. This cross section has the potential to significantly change in the future if during a large flood a debris jam occurred on any of the bridges that are present in this immediate reach.

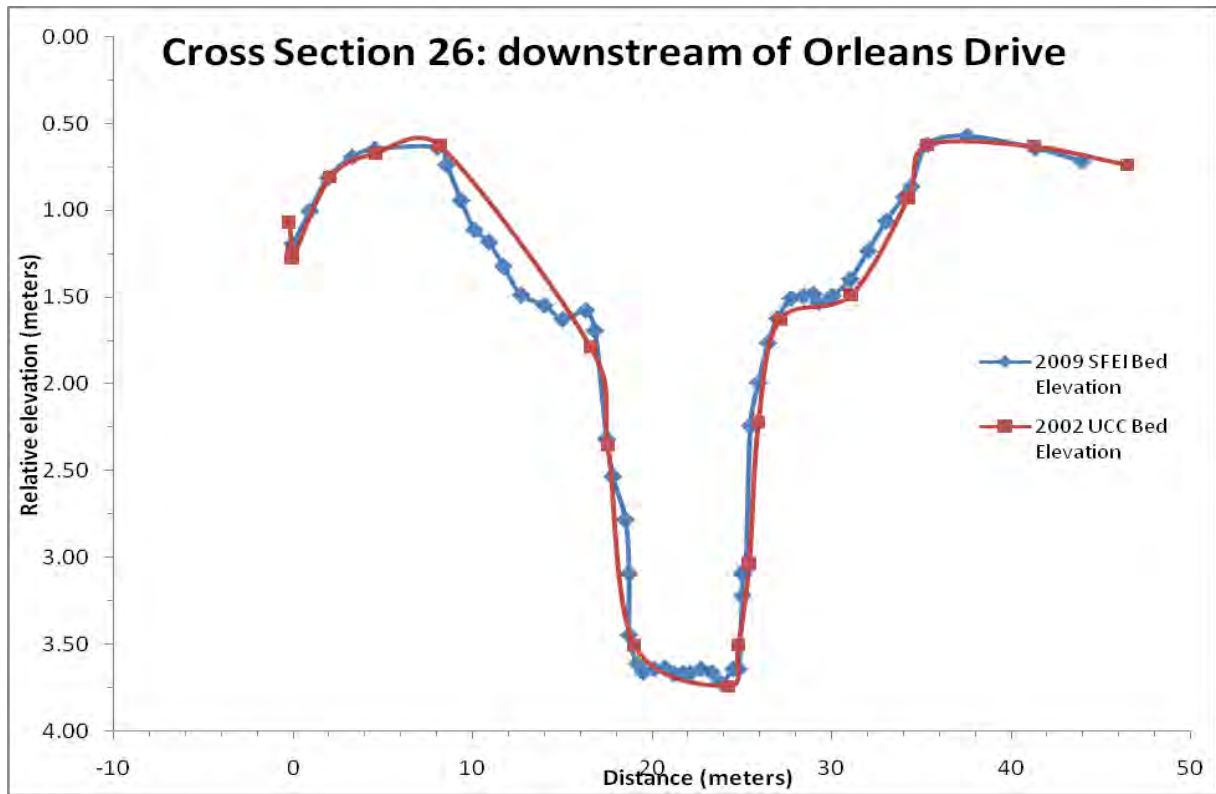
Figure 3a. Cross-section survey of Pinole Creek at Orleans Drive in August 2009.

Section 26 is located just downstream of Orleans Drive, and is the furthest upstream of the three cross sections. This section was not surveyed in 2006. Although we were unable to locate either rebar monument in 2009, based upon the field notes, we were within 1 m of the previous section location. The channel has a fairly flat-bottomed bed, vertical banks, and a floodplain surface that is inset from the paths. This floodplain surface is dominated by upland grass and weed species. The channel in this location has not changed significantly since 2002; overall it appears that the bed elevation has not changed. In addition, the right bank floodplain surface shows minor aggradation (<10 cm), while the data quality on the right bank floodplain limits our ability to quantify any change.

In 2012, we observed that the active channel dimensions have remained the same, with no bed elevation change. The constructed lower marsh plain elevation is very distinct as a result of the restoration work, as is the extra flood protection on the left bank because the path was raised during the restoration. Similarly to the previous cross section, the lower post-restoration floodplain surface has increased capacity and increased stability of the active channel during larger flood events.

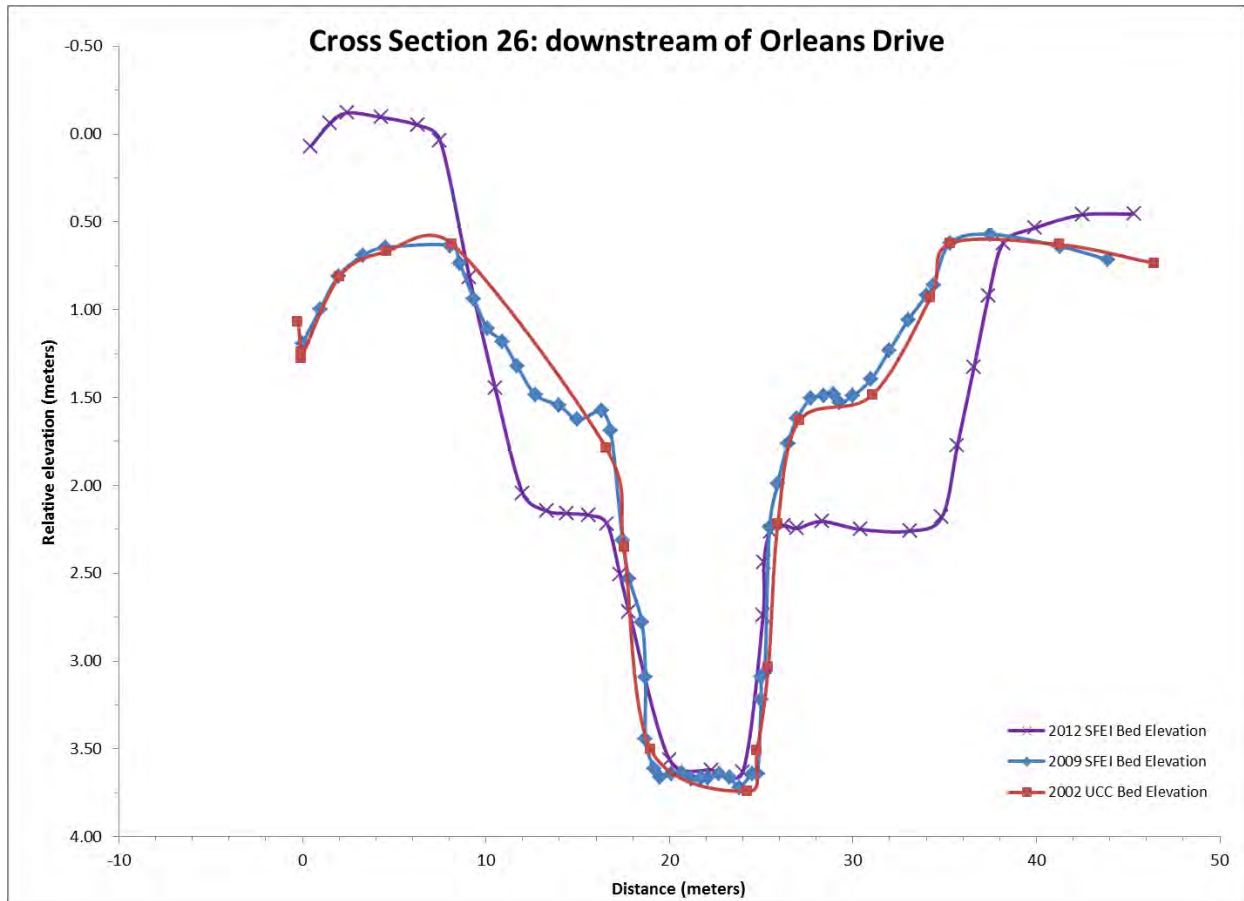
Figure 3b. Cross-section survey of Pinole Creek at Orleans Drive in August 2012.

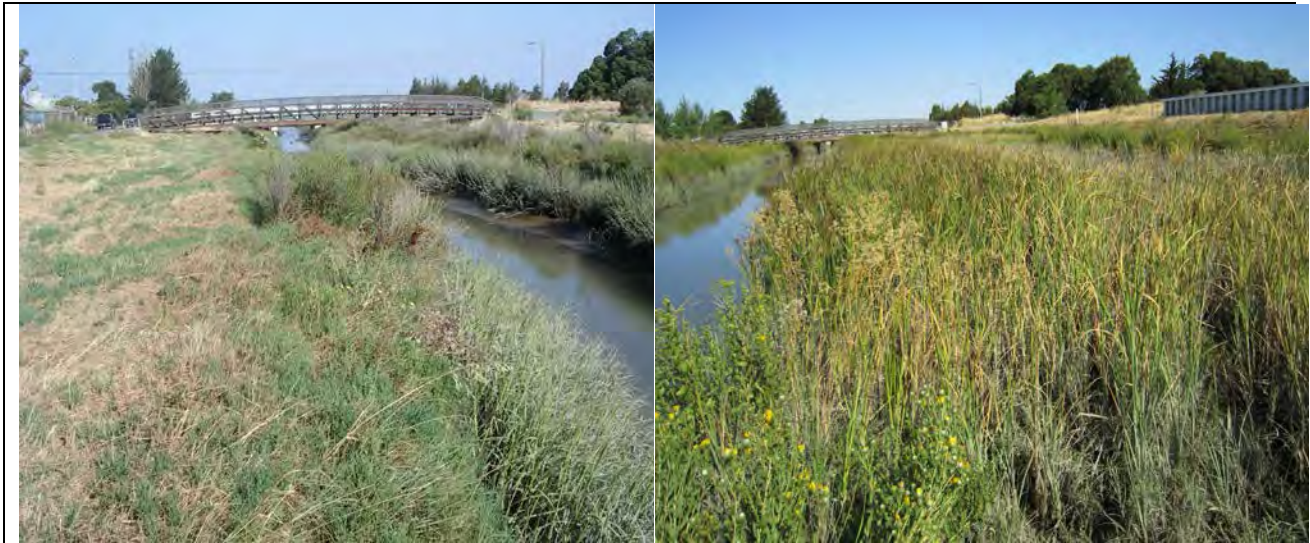
Figure 4. Pinole Creek #1 Assessment Area, looking downstream. 2009 condition on the left, with mowed upland grasses and weeds; 2012 condition on the right, dominated by tidal marsh species.

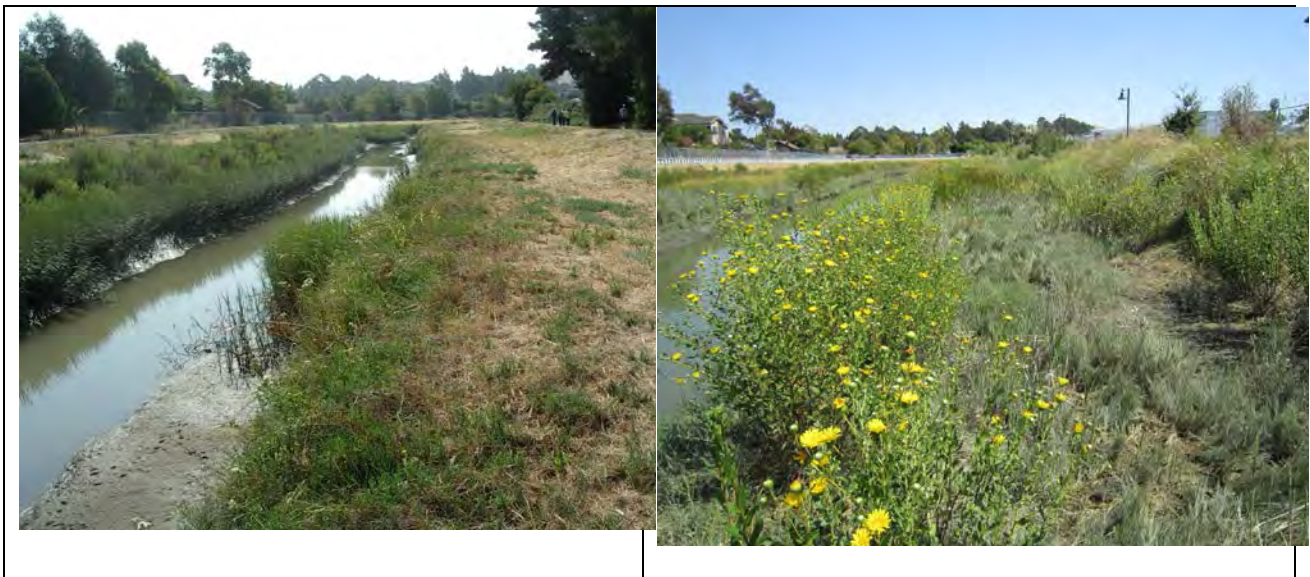
Figure 5. Pinole Creek #2 Assessment Area, looking upstream. 2009 condition on the left; 2012 condition on the right. Notice the change in plant community that has occurred, particularly on the left bank (right side of the photograph).

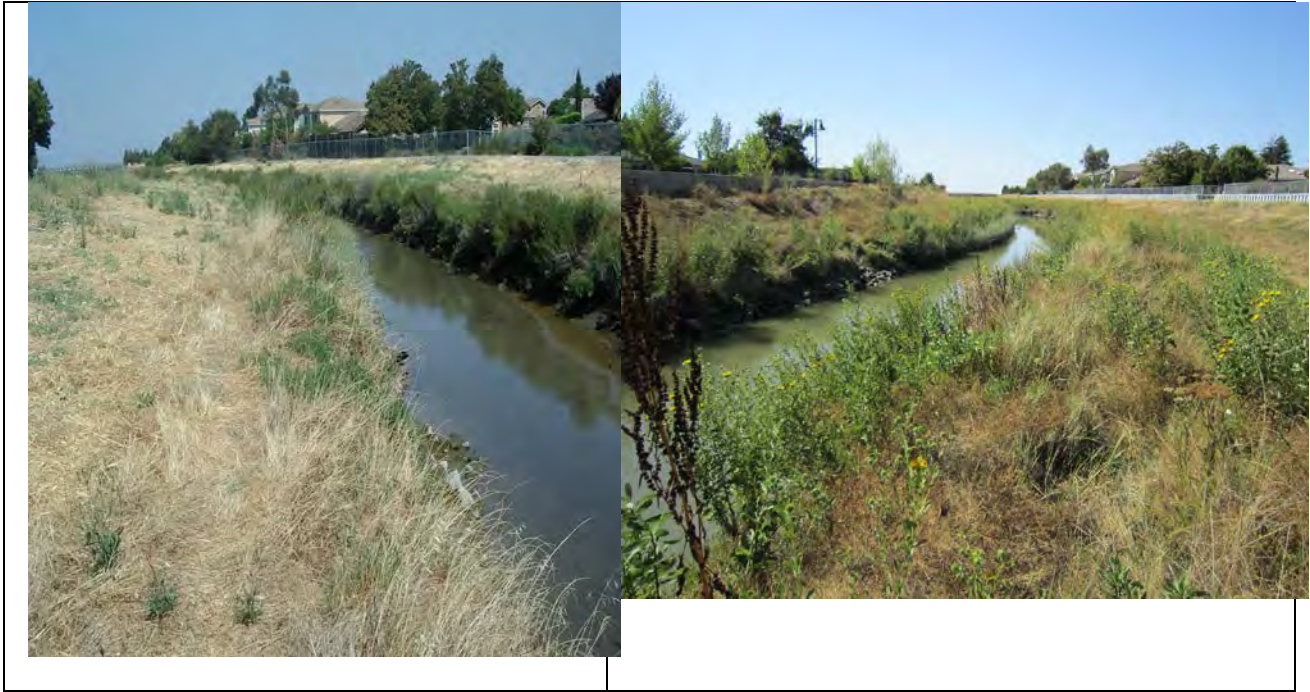
Figure 6. Pinole Creek #3 Assessment Area, looking downstream. 2009 condition on the left; 2012 condition on the right.

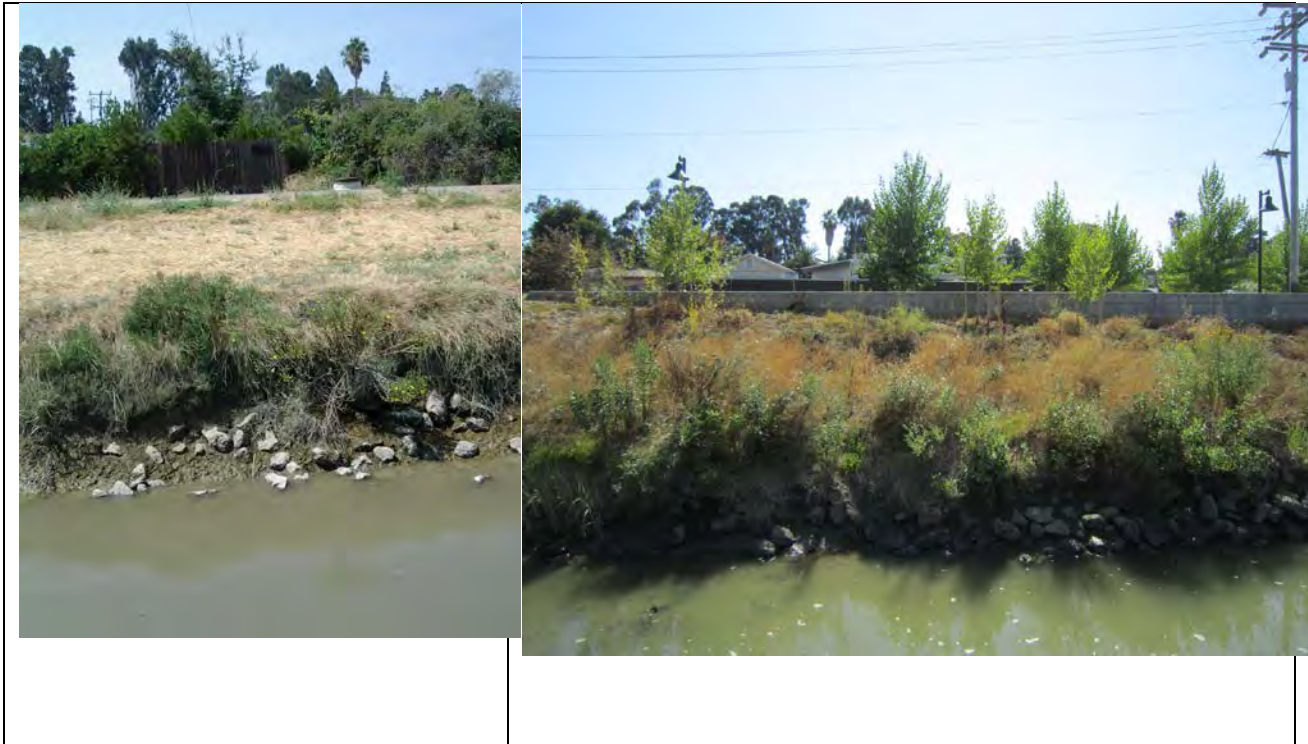
Figure 7. Pinole Creek #3 Assessment Area, looking at the left bank. 2009 condition on the left; 2012 condition on the right. Notice the increased amount and complexity of vegetation on the floodplain surface, the planted trees along the edge of the path, and the very similar condition of the channel bank.

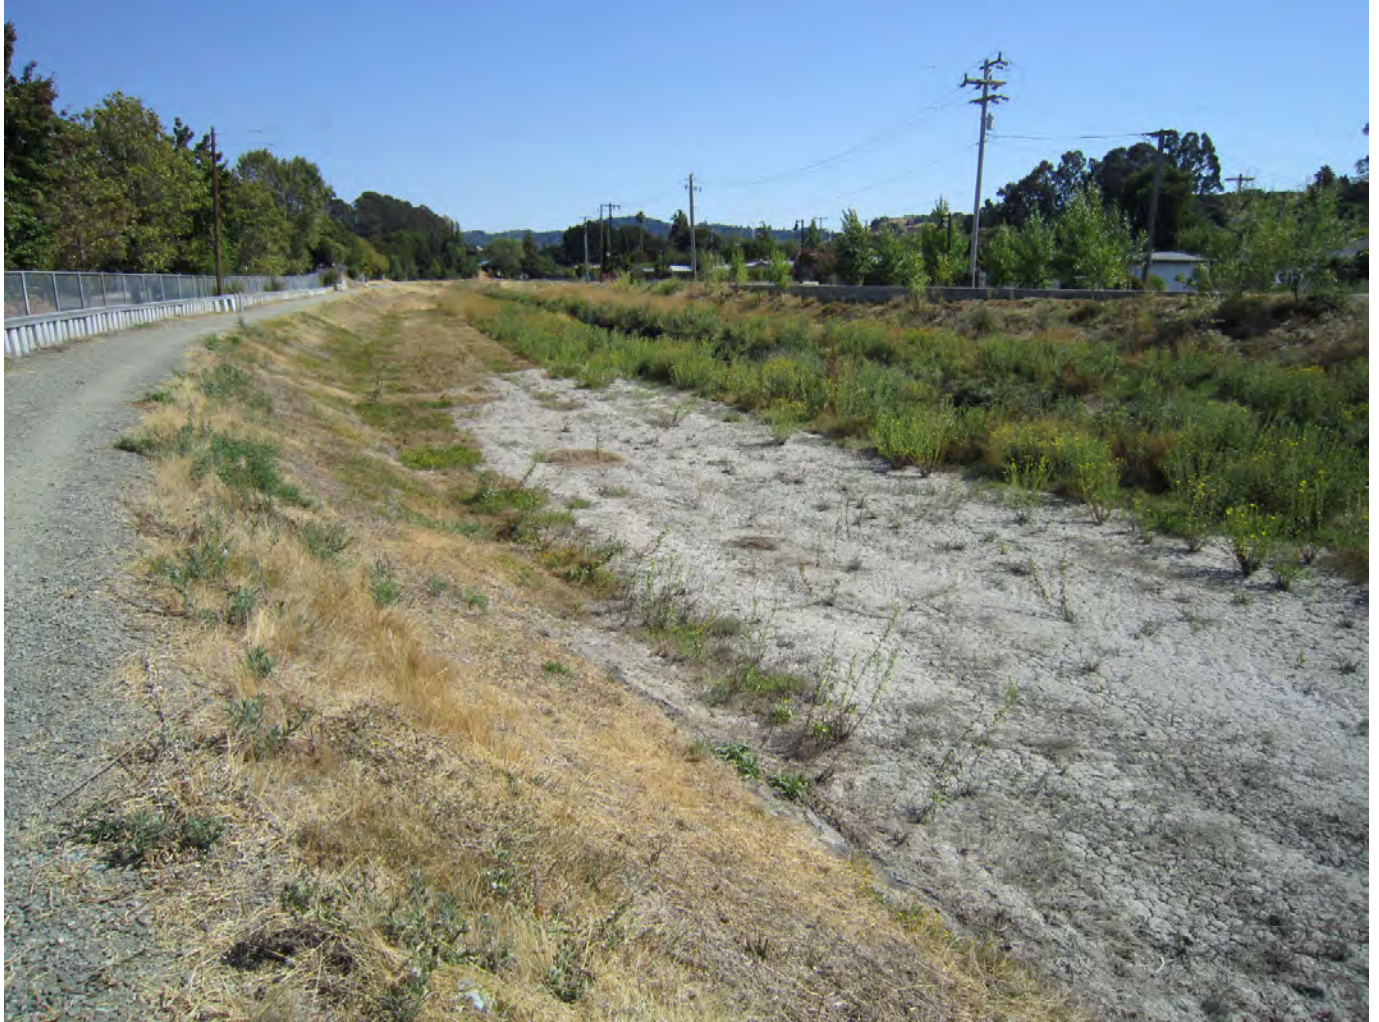
Figure 8. Pinole Creek #3 Assessment Area, looking upstream. Note the barren (foreground) and mowed (background) condition of the floodplain surface.

lower than the other two assessments, primarily due to the Biotic Structure; Figure 8 shows areas of barren ground and mowed vegetation on the right bank floodplain surface that contributed to these lower scores. Figures 9 and 10 show the Chelsea Marsh area, and the lack of change that has occurred between 2009 and 2012. Additional photos taken after the marsh restoration occurs would highlight the significant changes that will likely take place. Figures 11 through 13 document the pre- and post-restoration conditions at each cross section location. For each location, the low flow channel geometry has not significantly changed.

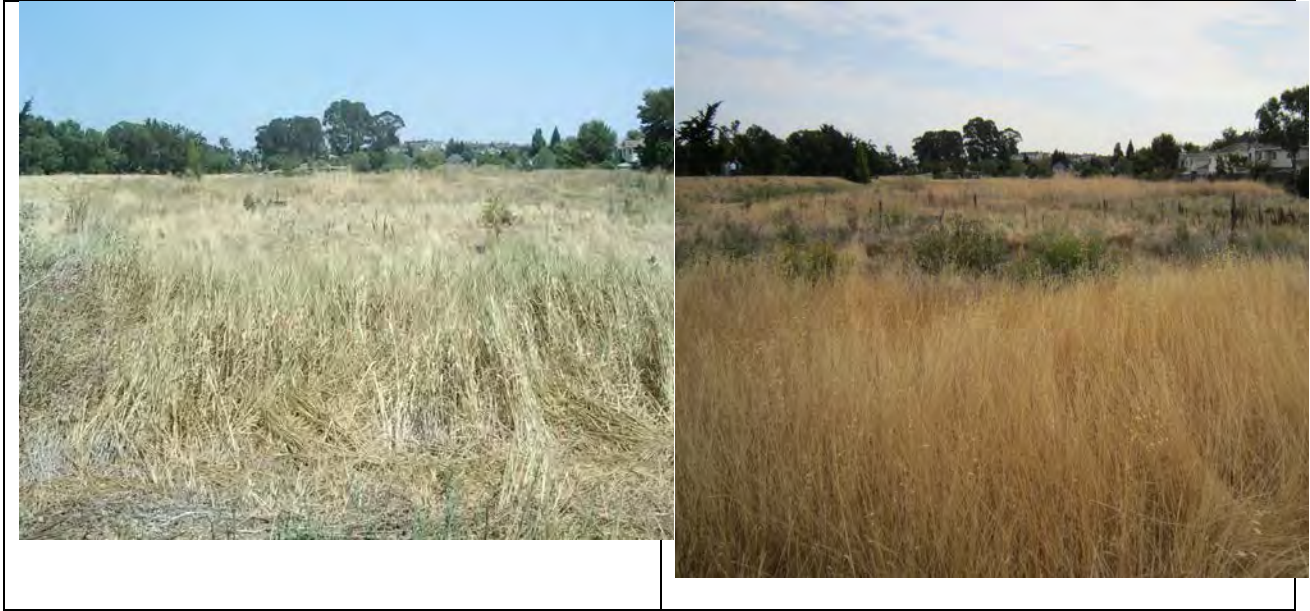
Figure 9. Chelsea Marsh #1 Assessment Area, looking east. 2009 condition on the left; 2012 condition on the right. Note the unchanged character of the upland area.

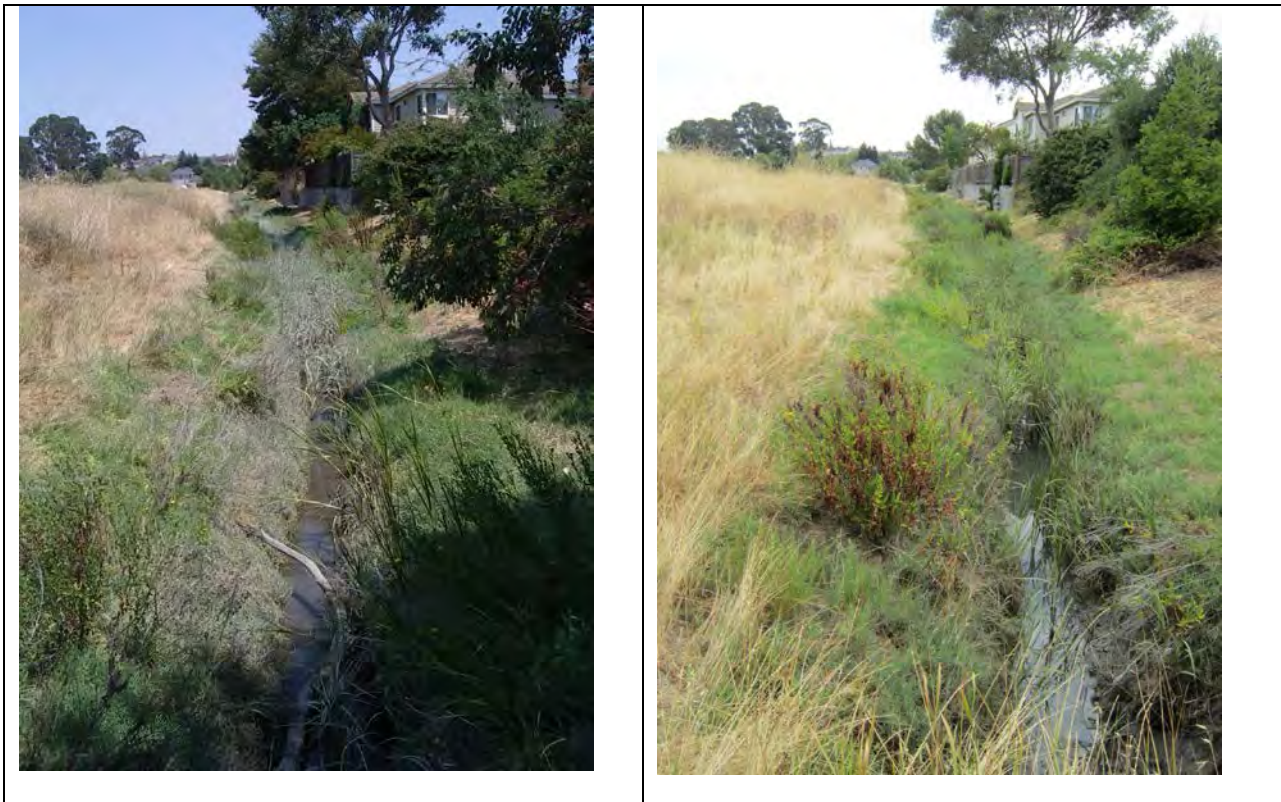
Figure 10. Chelsea Marsh #2 Assessment Area, looking east. 2009 condition on the left; 2012 condition on the right. Note the unchanged character of the tidal channel.

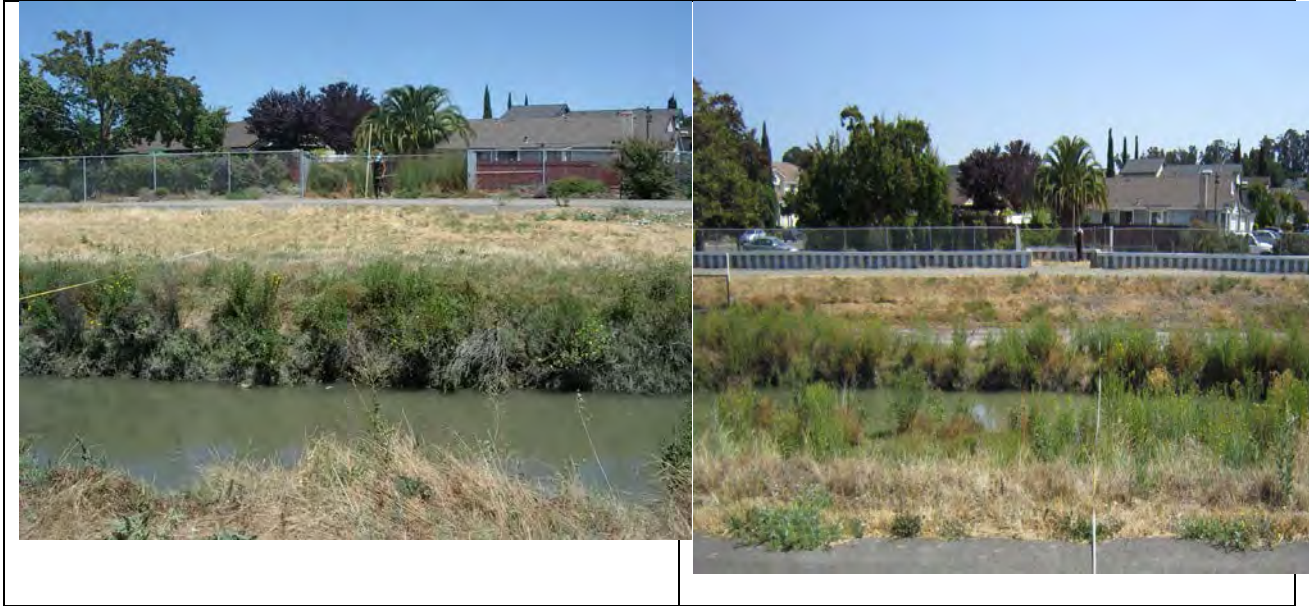
Figure 11. Channel cross section at Orleans Drive, looking at the right bank. 2009 condition on the left; 2012 condition on the right.

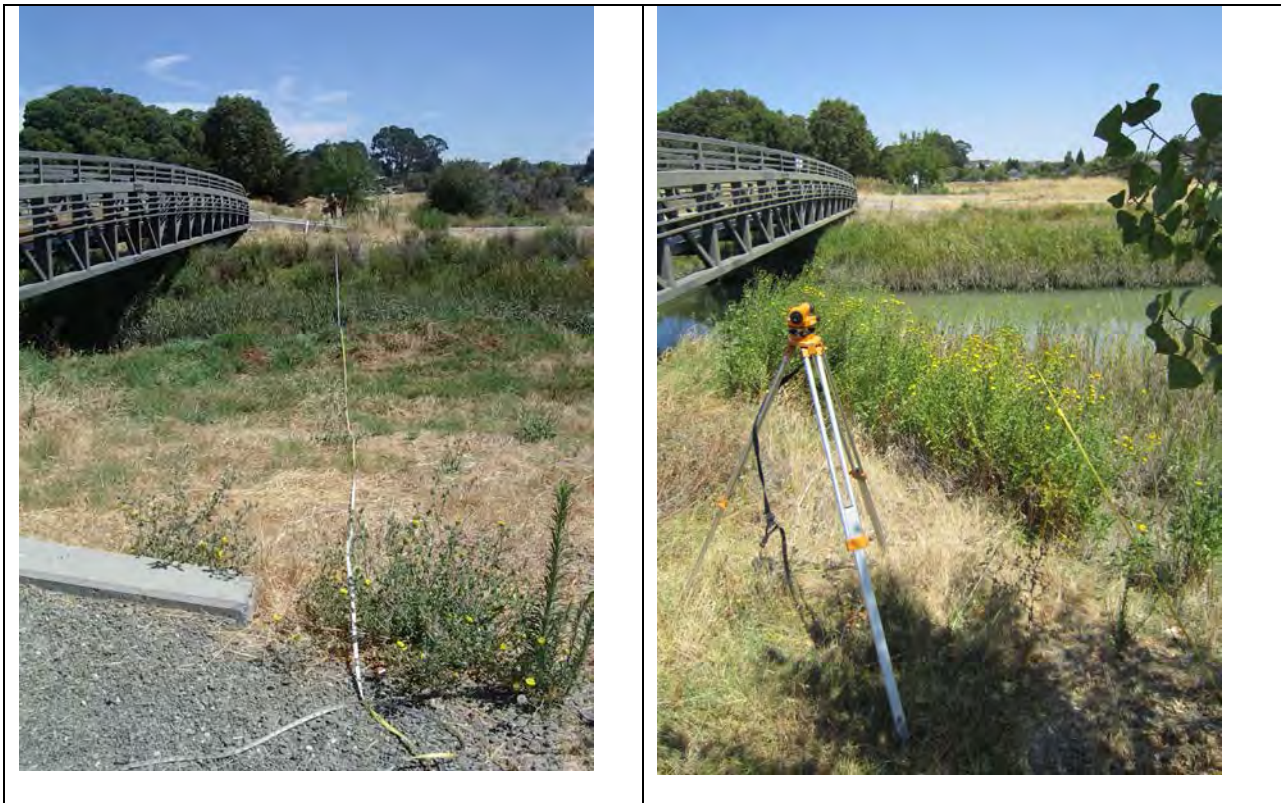
Figure 12. Channel cross section at Pedestrian bridge, looking at the right bank. 2009 condition on the left; 2012 condition on the right.

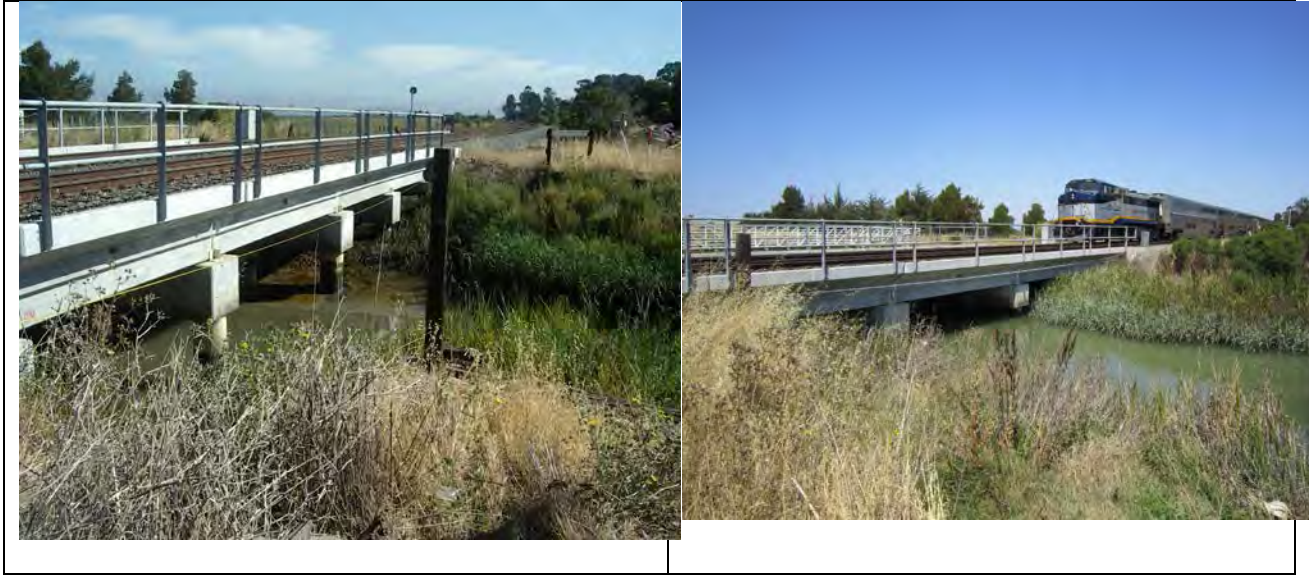
Figure 13. Channel cross section at the Railroad bridge, looking at the right bank. 2009 condition on the left; 2012 condition on the right.
